APPENDIX E  
LETTERS ON GEOLOGY AND HYDROLOGY

**Subject: Hydrologic Analysis of Burney Creek Overflows to Hat Creek Construction, Inc. Property**

RE: Mining Reclamation Plan for Rimrock  
 Corporation, Aggregate Products.

RE: Rim Rock Corporation Quarry  
in SW 1/4 of SE 1/4 Section 10, T36N R3E, MDM  
(Shasta County APN 23-250-14)

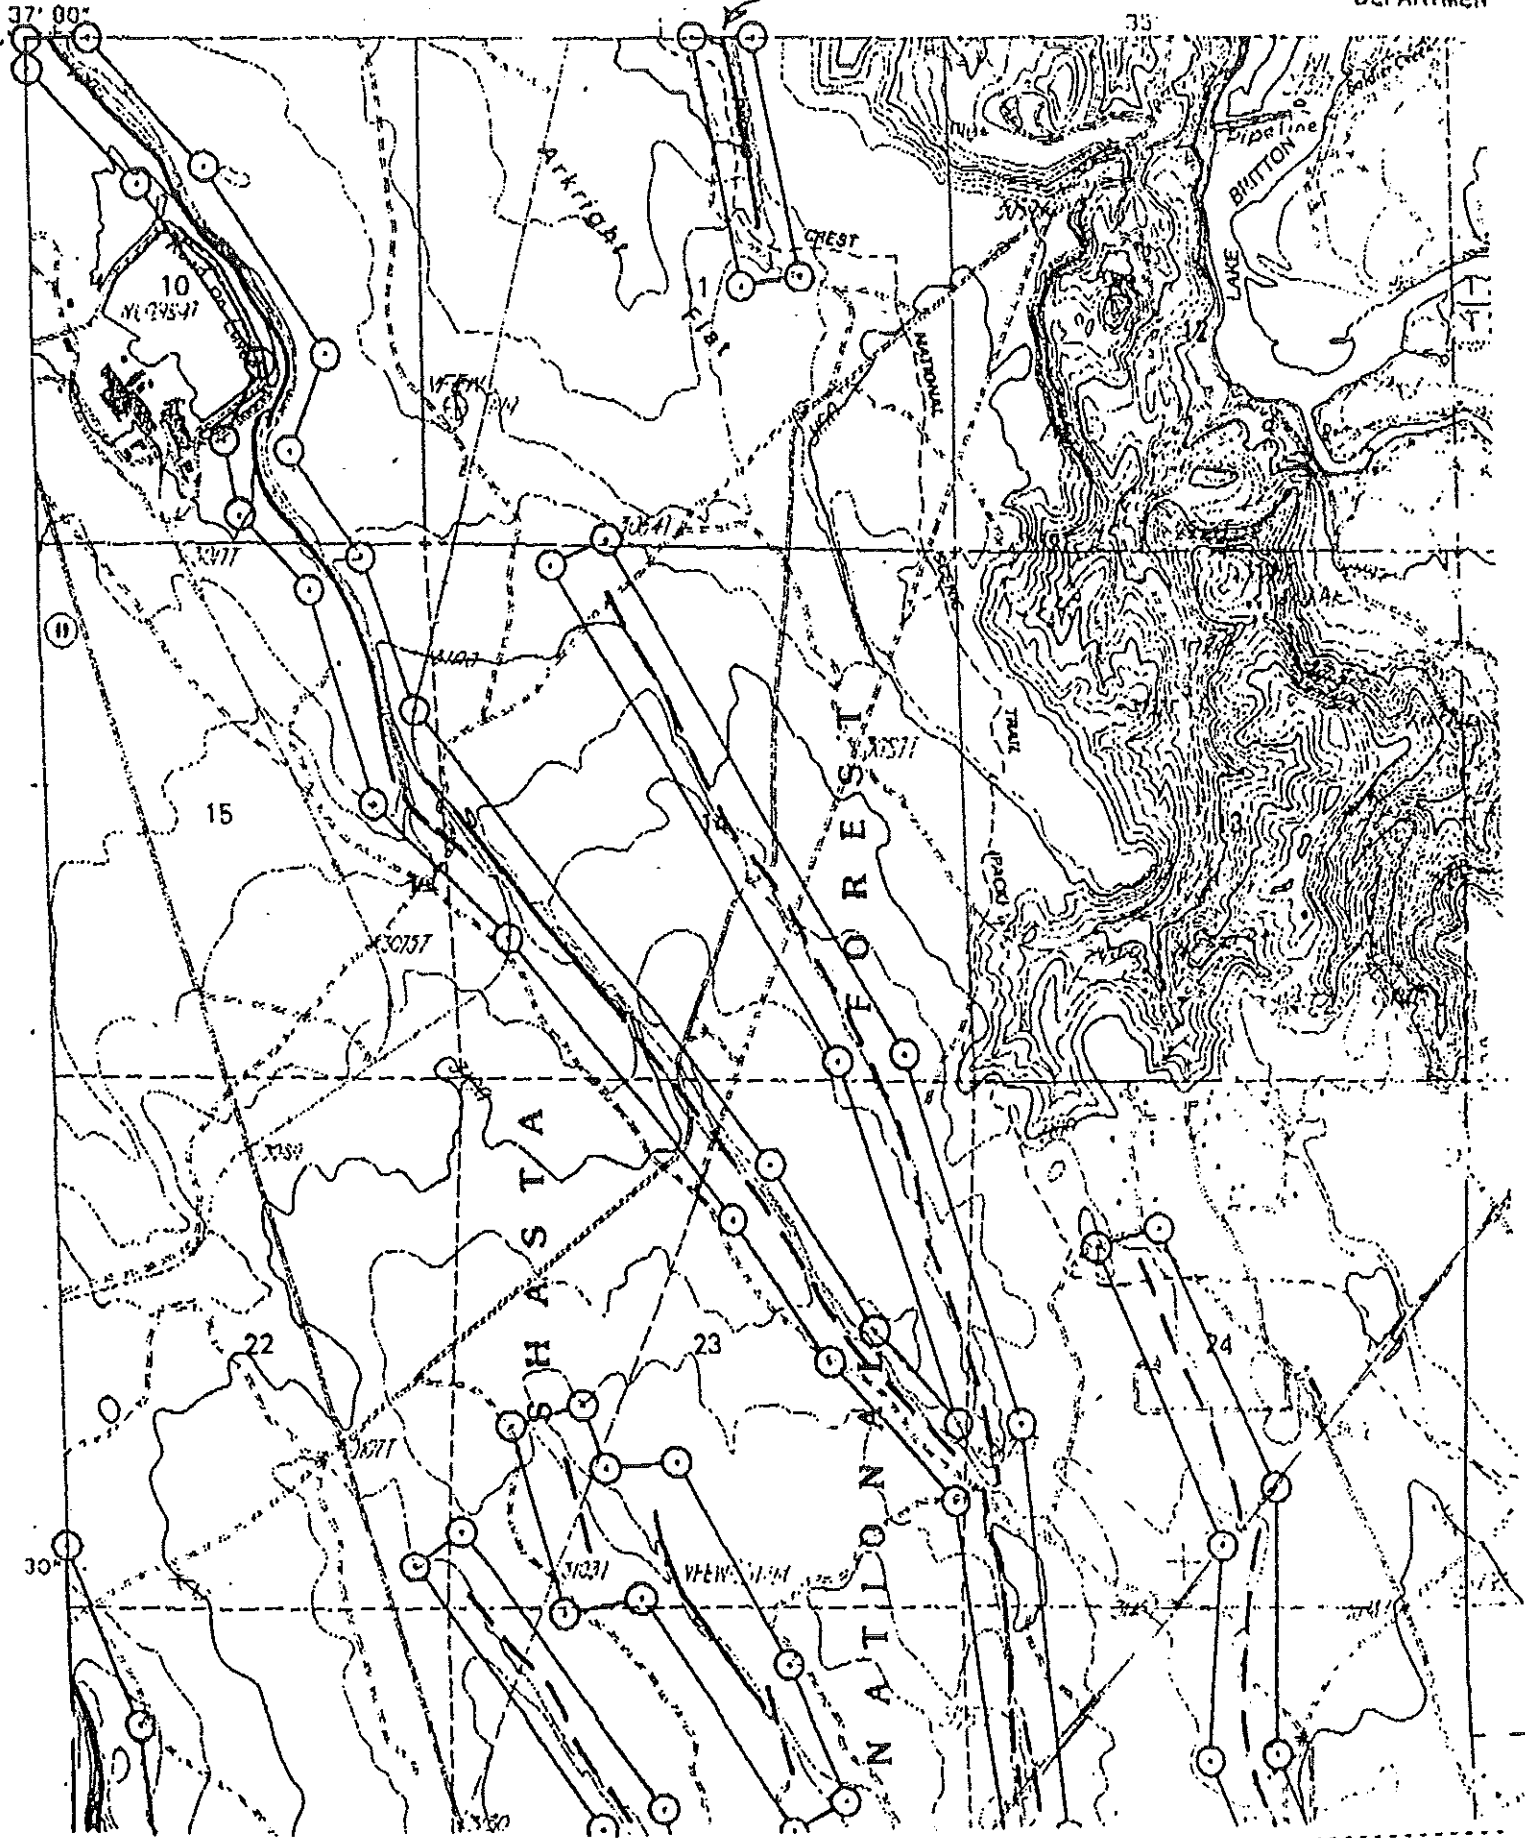
ALQUIST/PRIOLO  
ZONE?

In the past ten (10) years, some geologists have noted features associated with some of these escarpments which suggest fault movement has taken place along these scarps within the past 11,000 years (Wills, C.J., 1990, and Woodward-Clyde Consultants, 1987). Based on these reportings, these faults have been designated as Earthquake Fault Zones, and as such, building along these zones is regulated in conformance with the Alquist-Priolo Earthquake Fault Zoning Act. It is therefore recommended that any permanent buildings be situated as depicted on the State of California Special Studies Zones, Cassel Quadrangle, Preliminary Review Map of May 1, 1991.
